Earthquake rehabilitation and reconstruction in Uttarakhand

REHABILITATION PROJECT AT VILLAGE-AUNGI, DISTRICT UTTARKASHI, UTTARANCHAL (safeguard against earthquake)

Architect Anant Tankha and Associates - New Delhi

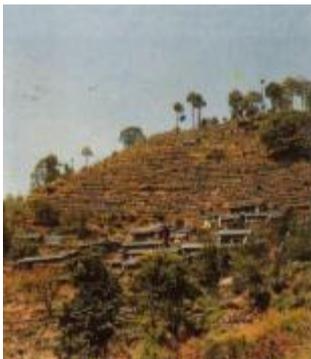
Village AUNGI (Photo shot from school)

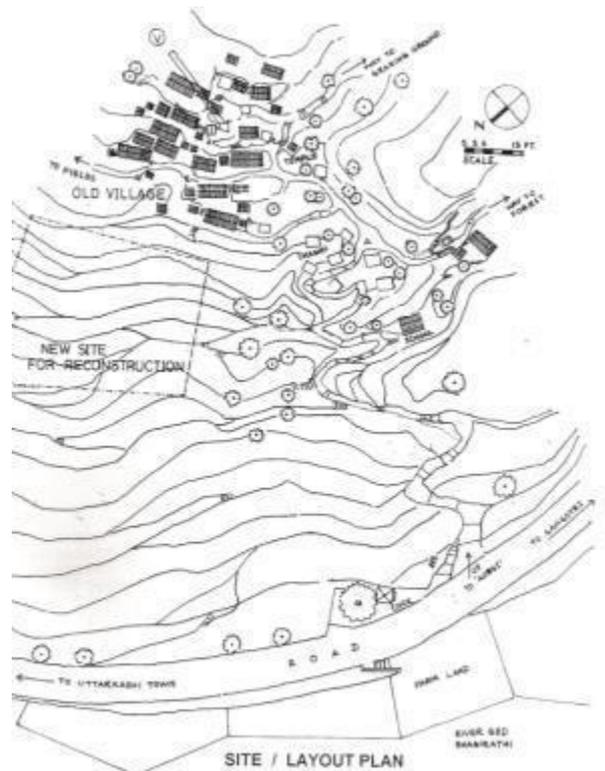
CLUSTER DETAIL "V"
(Refer Site /Location Plan No. 01)

CLUSTER LEVEL ELEMENTS:

KOTHAR

For storing grains

CHANNIS:

For keeping livestock

ROOM UNIT:

For habitation/cooking

CHOWK:

An open terrace for sitting and performing daily cores

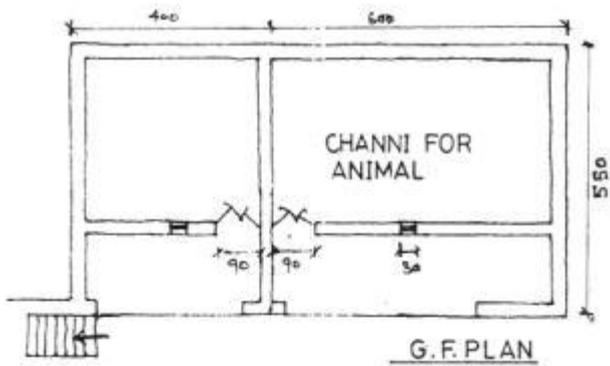
G.F. PLAN

- Channis on ground floor for livestock for protection from wild animals
- Room for dwelling on first floor
- Small doors and very small windows fenestration area only 5% of the covered area for harsh cold climate
- East sided veranda. For direct sunlight
- Alcoves for lighting lamps
- No designed space for storage
- Cooking inside room, keeping it warm and sooting wooden members one of the reasons for long life of wood
- Veranda railing, doors and wooden eaves of the roof being the only aesthetic part of the design
- Mud floor in channis, and wooden floor on the first floor unit
- The plan is rectangular and unsymmetrical due to the narrow hill terraces. And lack of space for expansion the proportion of length and width of the dwelling units varies 1:2 to 1:5 expanding only laterally

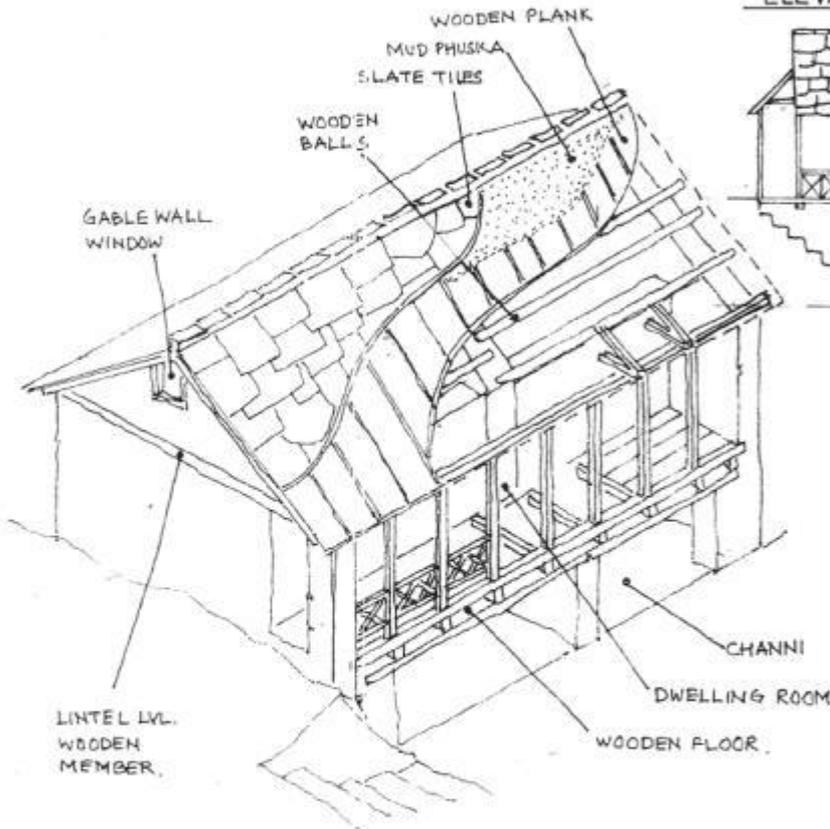
ISOMETRIC / 3D-VIEW

- The houses are composite of stone mud wood and slate. All locally and abundantly available in the area
- The houses are 20 to 80 years old and are built over a period of time collecting the best wood stone and slate tile from the forest.
- The roof is made out of wooden ballis laterally placed on side gable walls supporting wooden planks with mudphuska and slate tiles on top
- For ventilation of cooking smoke a window at top of gable wall is provided
- Wooden plank/sq. Balli is provided at lintel level for tying up the whole structure
- Veranda is made of wooden plank floor with corner stone masonry post and intermediate wooden posts supporting the wooden members of the slate tile roof above

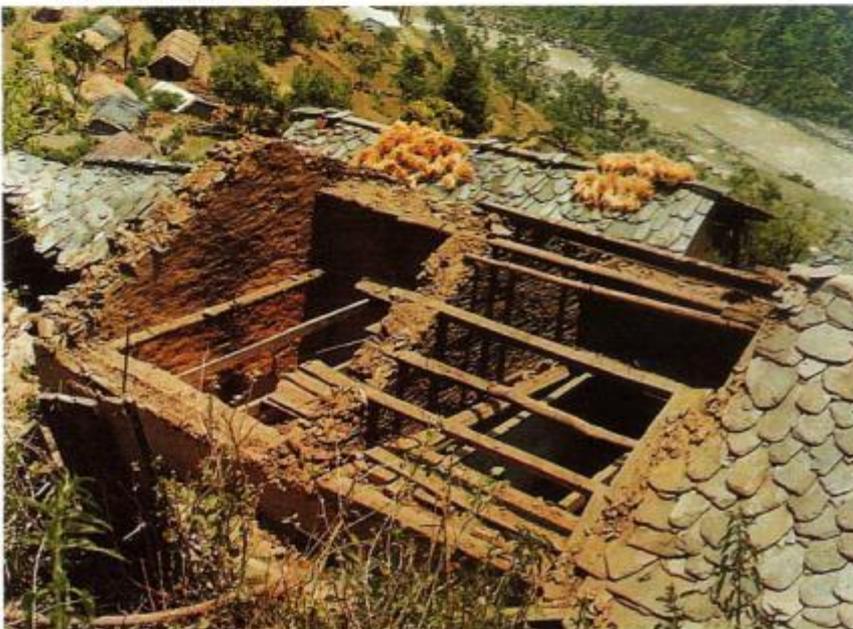
Photograph of Typical Village House -Dismantled:

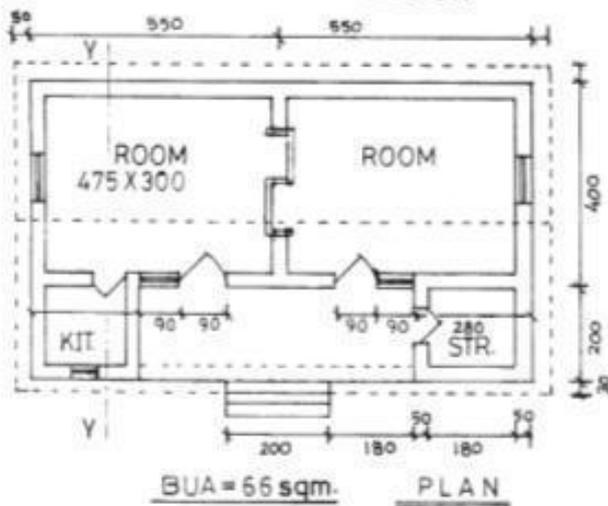
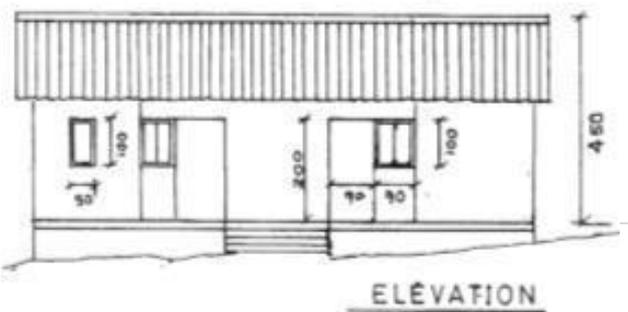
THE NEW DWELLING UNIT DESIGN

- PLAN is
 - *Rectangle, with length width ratio less than 1:2.
 - *Symmetrical for balanced loading on foundation
 - *Only ground floor structure, in the present context with no danger to livestock from wild animals, it is proposed to convert old village into channiss.
- No gable wall
- Fenestration area 15% for hygienic ventilation
- Doors and windows away from wall corners, thus not waking the corner joints of the wall.
- Separate room for cooking, opening inside, thus keeping the house warm and also not sooting the house.
- A symmetric room as "store" traditional "kothar" in its contemporary context.

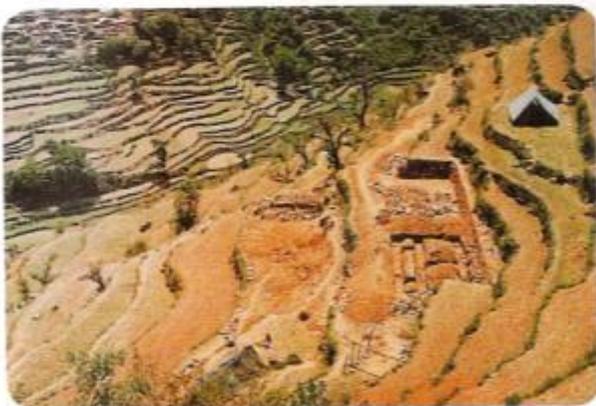
Terrace cutting and excavation

Excavation for foundation to be done leaving at least 1.0 mtr setback from the back terrace, to protect the back wall of the dwelling unit from a possible breaking loose of terrace during earthquake

The setback from the edge of the terrace (Refer drawing on left, marked "a") to be more than the depth of excavation (marked "b") to avoid dislodging of the terrace edges

The excavated earth and building material for construction should not be dumped on the outer edge of the terrace, resulting in dislodging of the terrace edge.

However if above are not possible due to restriction of the width of the terrace and dwelling unit design, a retaining wall in stone masonry Be provided with weeping holes.

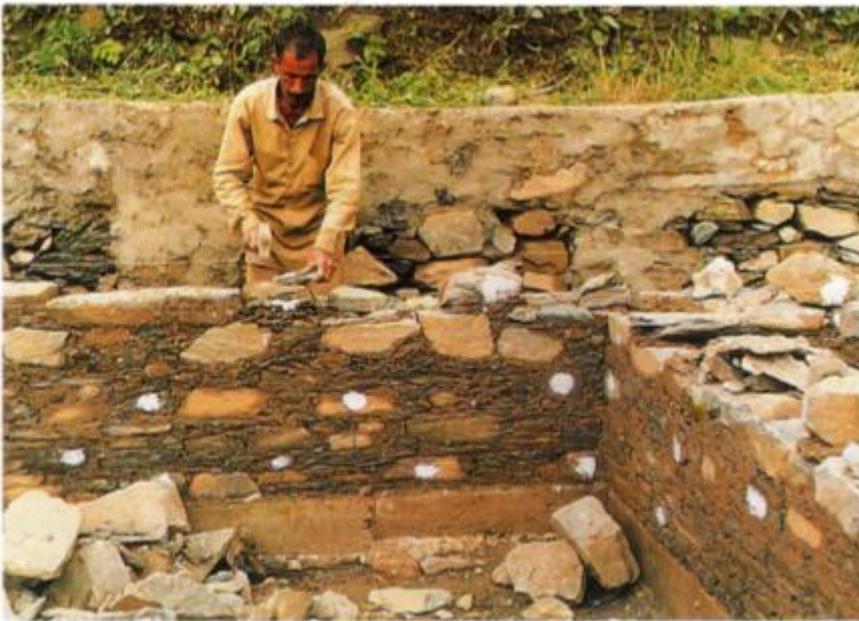
2 Thru stone marked with white lime

Longer thru stones are provided at an interval of 0.9m in alternate stone masonry courses, binding the wall

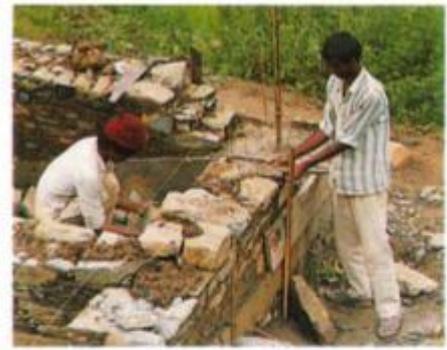
3 Corner casting in Cement Concrete

Engineering a cross structured wall corner or junction in stone masonry Wall is impossible as such a concrete cast corner is designed with 2no. 12 dia tor vertical bars for shear. The corners are casted simultaneously with each course of stone masonry, such that it makes toothed joint corner at the wall junction.

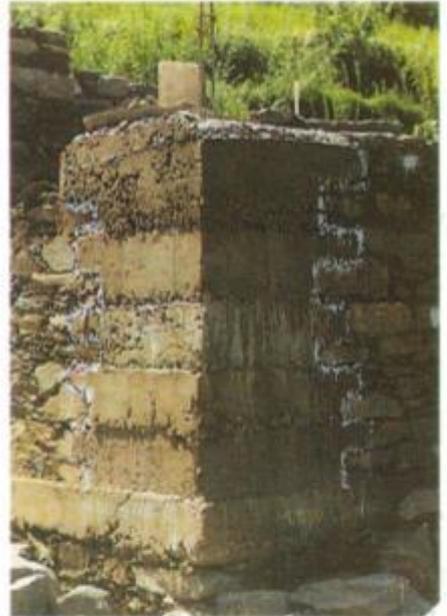
4 Toothed Shaped Casting of Corner

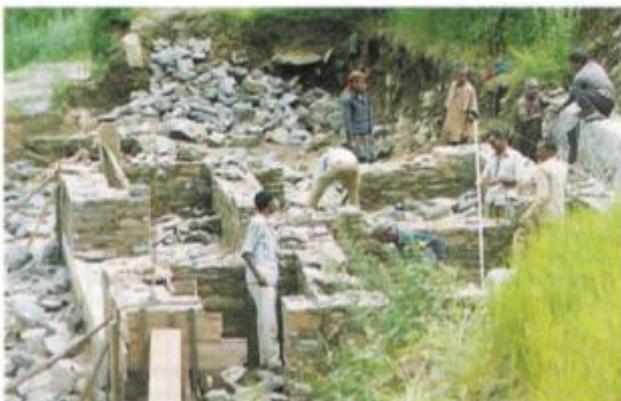
6 Construction of dwelling unit

--Wall Corner and junctions

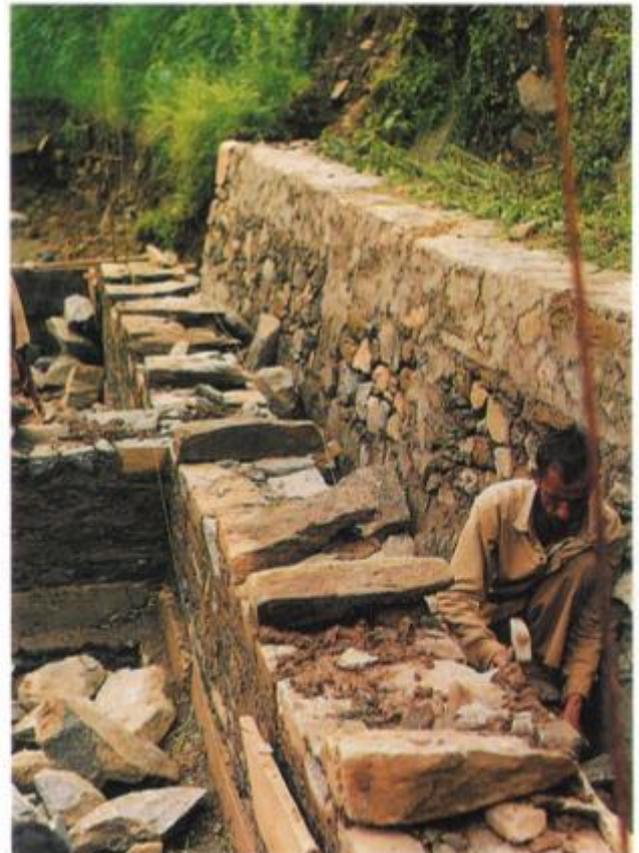
1 Thru Stone for Stone Masonary wall

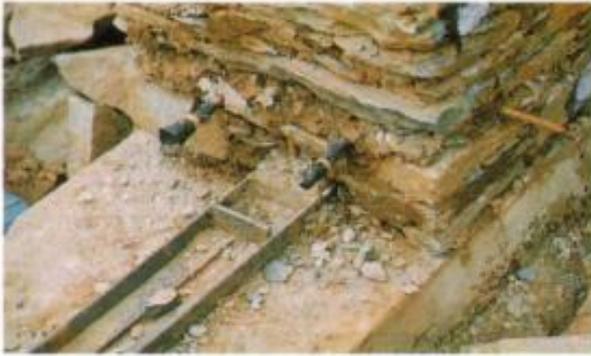
DOORS AND WINDOWS

The doors and windows are provided at a distance of 0.6m or more from the wall corner or junction.

The door chaukhat in wood is firmly tied to plinth beam with ms frame and bolts at plinth level, and lintel beam, thus it does not lead to distortion of door chaukht during the earthquake jamming the doors.

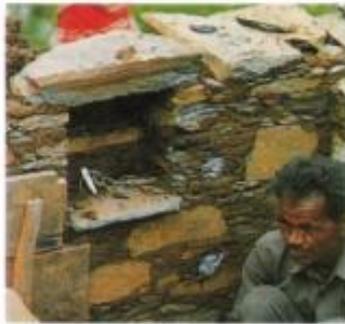
10 MS member bolted to Plinth beam To house wooden chaukhat

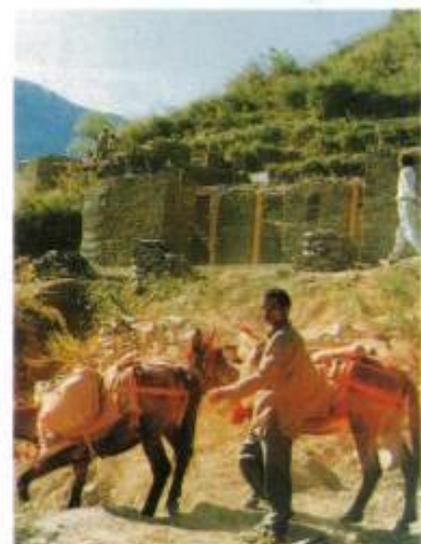
8. Construction: mules as means of Transporting stone.

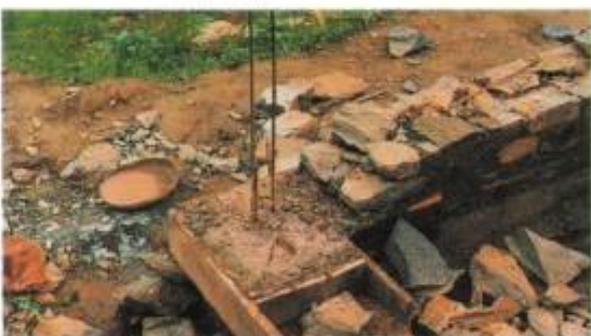
5. Construction of Dwelling unit

To understand the connectivity of all components of the dwelling unit design, the body of a passenger bus can be compared/quoted, which is rectangular in shape and travelling thru potholes on roads it shakes with flexibility, all members, floor, door, windows, roof snaking with flexibility damping the effect.

In a similar fashion for the new dwelling unit, the foundation is tied with plinth beam ----- the plinth beam is tied to wall corners thru concrete cast corners ----- which are in turn tied to lintel beam ----- supporting roof truss anchored in the lintel beam ----- the wall is sandwiched between plinth beam, lintel beam and cast corners ----- the wall is further tied up in itself by systematically laid thru stones

The components are interlinked and ties, with enough flexibility to damp the Earthquake shock.

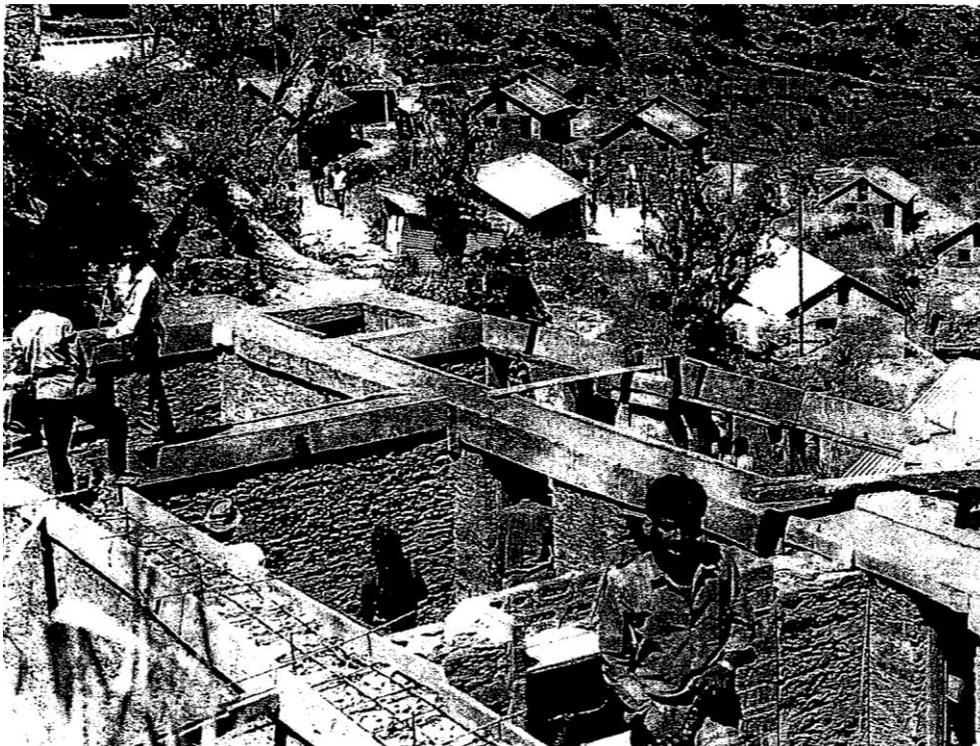
Construction work in full swing at Uttarkashi. In the background are completed houses.

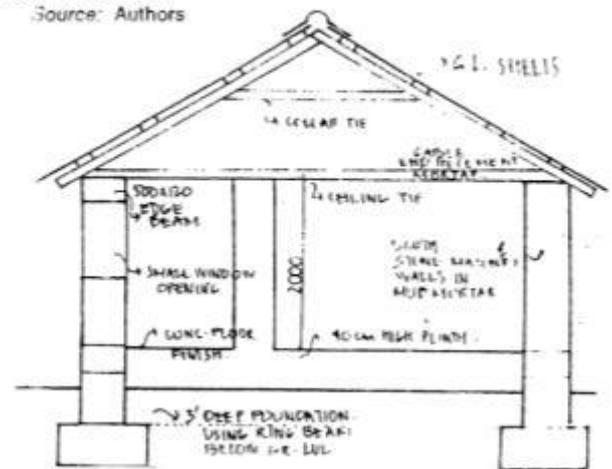
F49. Jnit section
Source: Authors

In terms of the plan as well as the choice of materials, these houses are the nearest to their traditional counterparts. Living rooms are arranged in a row, all entered from the verandah in the front. Apart from these, a kitchen and store has also been provided. Walls are made of stone laid in mud mortar with bands of concrete at various strategic levels. Heavy timber rafters support the CGI roof on top.
