# Inclusive emergency response

reaching out equitably in Leh-Ladakh

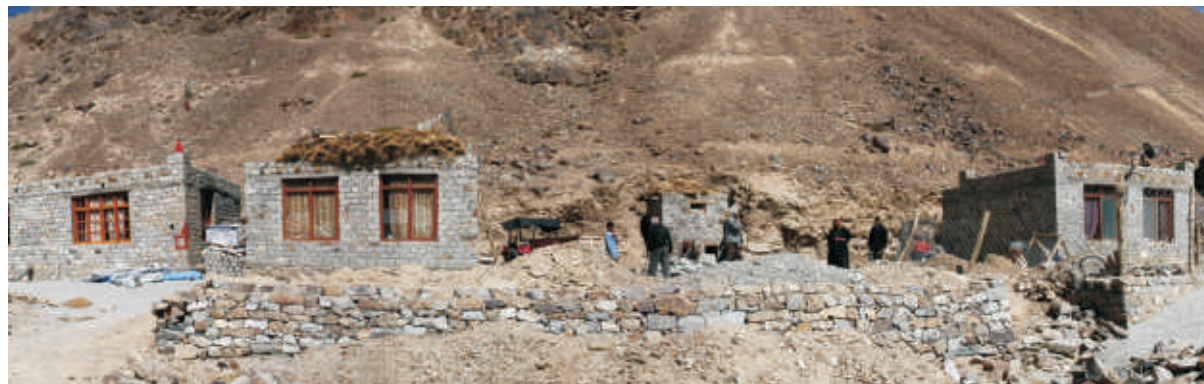
### Core stone shelters with a twist

The core shelters consisted of a single room with a fusion of sustainable Ladakhi design and modern safety standards. Built with local stone hewn from the hills, they used passive solar heating. This includes double-paned south-facing windows, several layers of ceiling insulation as per the local custom, one foot of insulation beneath the floor and one sawdust-insulated wall in each house. The shelters even passed a temperature test conducted during the bitterly cold months of January and February – water left in a container inside did not freeze overnight.

CASA has also incorporated elements of earthquake resistance such as iron rod corner reinforcements and a 6-foot deep stone foundation.

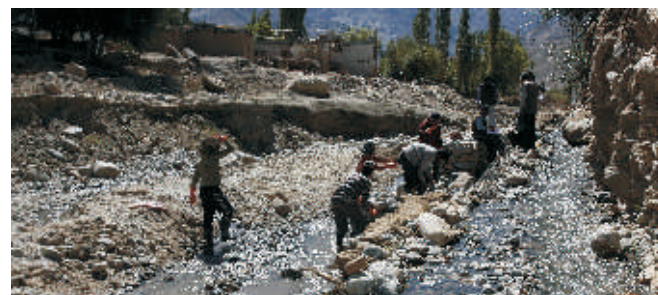
### Reviving essential water lifelines

Water scarcity and the resulting impact on livelihoods was unearthed as another core problem. So rather than continue shelter reconstruction, the restoration of canals was taken up in the second phase.

Located just below some glaciers, the irrigation canals in Phyang have historically been vulnerable to repeated floods. This large village houses 450 families, many of whom are completely dependent on agriculture. When all 42 of the village's canals were destroyed in the 2010 flash floods, the need to rebuild swiftly and strongly became imperative.

With CASA and RDY's help, a main irrigation canal here was restored. It followed a stone and concrete model, but added an extra layer of protection. An underground side wall measuring 15 foot length, 4 foot width and 5 foot deep was built just before the sluice gate to protect the actual gate itself.

The simple gate contraction means that the traditional water sharing method can still be followed. When the shadow of the mountain hits the designated stone in the village, the canal closes. When the birds start chirping, it opens again.

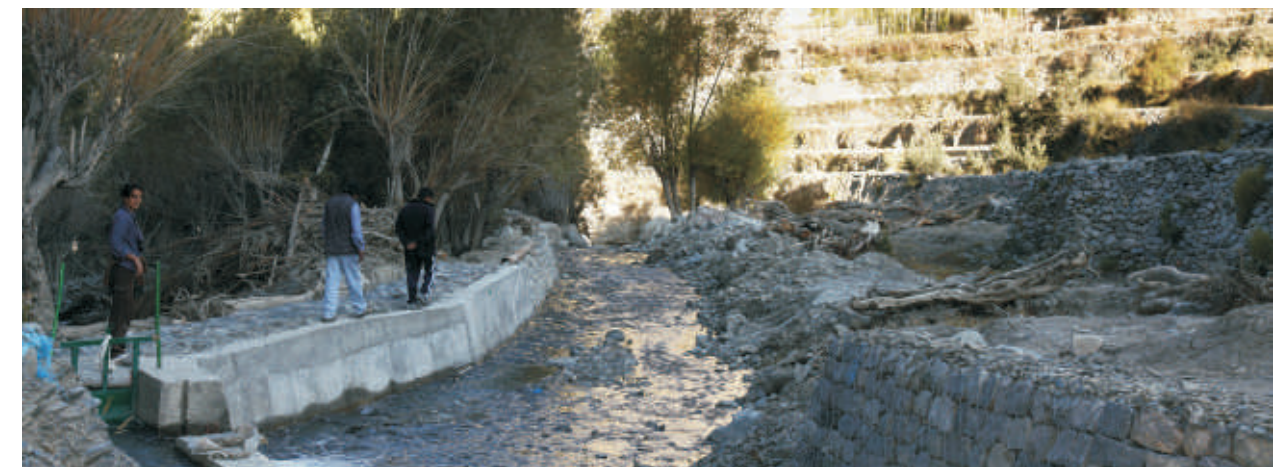
In Temisgam, water has always been so plentiful that traditional rotation systems were seldom needed and conflicts over water access were few. The floods, however, transformed a meandering and green stream valley into a wide and rugged channel, devoid of vegetation. The original canals have been left shattered under 30-50 feet of silt.

CASA's three canals built here collectively covered over one thousand feet, irrigating 400 acres and benefitting 220 families. From now onward, the canals will be maintained as they always have been. Before sowing season, the users of a particular canal agree on a date to collectively do routine maintenance, cleaning and small repairs. In other words, everyone shows up and does their part!
